(54) **TRANSMISSION SYSTEM AND METHOD OF REPAIR**

A transmission system and method of repair having a transmission servo rod received within a transmission housing bore, the rod having an aperture disposed along an exterior surface of the rod, configured to receive transmission fluid from a port within the transmission housing bore, a first recessed groove in the exterior surface of the rod disposed above the aperture; a second recessed groove in the exterior surface of the rod disposed below the aperture; and a first and second resilient sealing member received within the first and second recessed grooves, respectively, the resilient sealing members configured to engage an inner surface of the transmission housing bore.

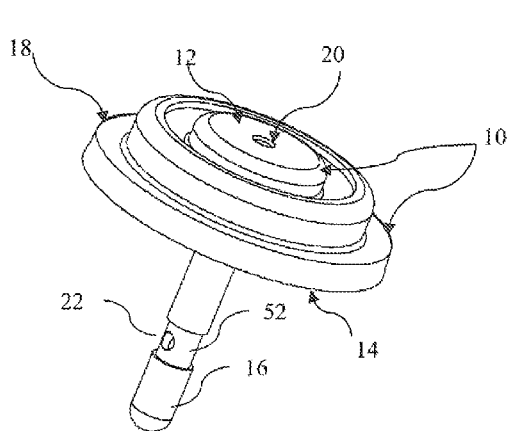
FIG. 1  
PRIOR ART

FIG. 1 is an isometric view of an OEM servo detailing a rod, piston, and relative position of parts and characteristics used to describe the invention;

The OEM servos consist of a rod 16 and piston 12 & 18 (see FIG. 1). The servos have a cross bore 22 that is centered on a wide groove 52 that is machined into the rod. The large groove allows for fluid to pass into the cross bore 22 while the servo is extending and retracting (see FIGS. 1, 4, 6, 7, and 21). The rod 16 on the servo has a bore 20 running through the center of the rod from the cross bore 22 to the top of the piston 12 (see FIGS. 1, 4, 6, 7 & 8). As part of the OEM design, when the solenoid (not shown) for that servo is activated, the pressurized transmission fluid passes through the cross bore 22 in the rod 16 up to the top side of the piston 12 between the piston 10 and the servo cap 36. Some fluid also passes to the bottom side of the piston 14 and to the reservoir 40 (See FIGS. 1 and 7). This is an inherent part of the OEM design. The system is designed such that the intermediate servo which engages, for example, the 2<sup>nd</sup> through 4<sup>th</sup> gear range, and the overdrive servo (not shown), which engages for example the overdrive or 5<sup>th</sup> gear, has an acceptable amount of transmission fluid that leaks past the clearances 46 between the servo rod 16 and the servo bore 20. Therefore, given the design, a percentage of fluid is designed to not flow to the top of the piston on the servo (see FIGS. 7-10). When the clearances between the rod and the bore 46 are still small enough, there is sufficient pressure 42 supplied to the top of the piston 12 to properly activate the desired gear range.

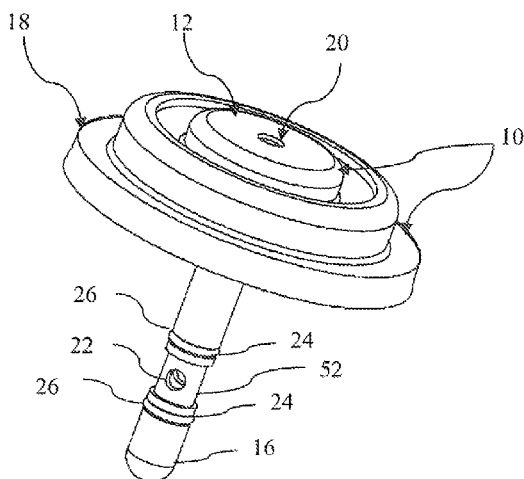
FIG. 2 is an isometric view of a modified OEM part with machined o-ring grooves and o-rings;

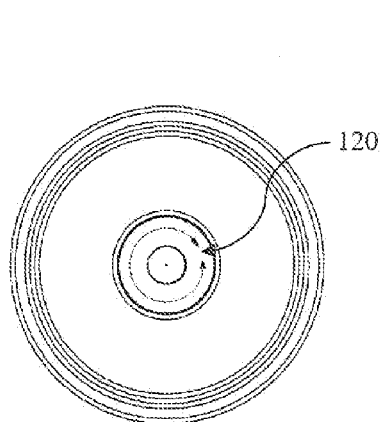
FIG. 3 is a bottom view of a core section of an intermediate servo as it would appear from inside a transmission looking out.

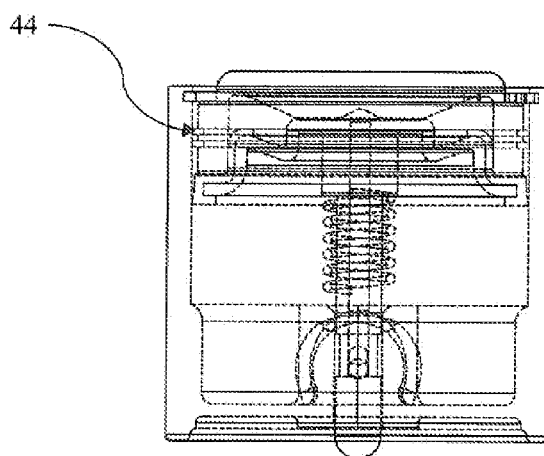
FIG. 4  
PRIOR ART

FIG. 4 is a front view of a core section of the intermediate servo showing the servo, including the piston, bore the rod goes through, snap ring, and return spring;

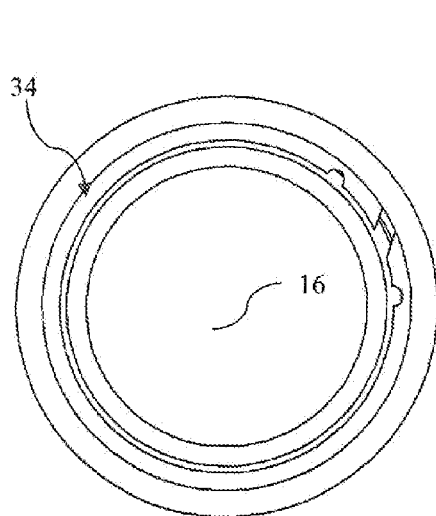
FIG. 5 is a top view of a bore section of the intermediate servo showing a cap and the snap ring that holds the cap in place;

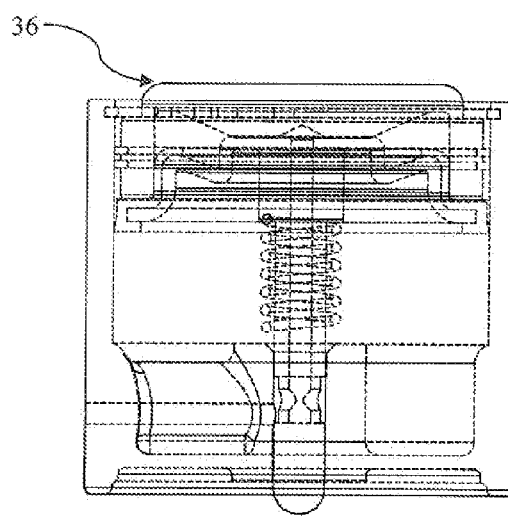
FIG. 6  
PRIOR ART

FIG. 6 is a side view of the bore section of the intermediate servo showing a fluid port and the same components as in FIG. 5;

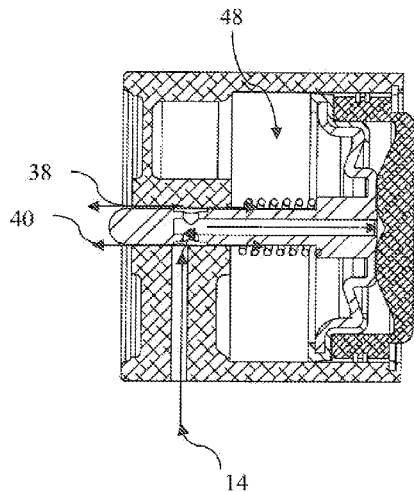
FIG. 11  
PRIOR ART

FIGS. 11 & 12 are cross section views showing wear to a bore over the life of the vehicle and additional flow points of transmission fluid causing pressure loss;

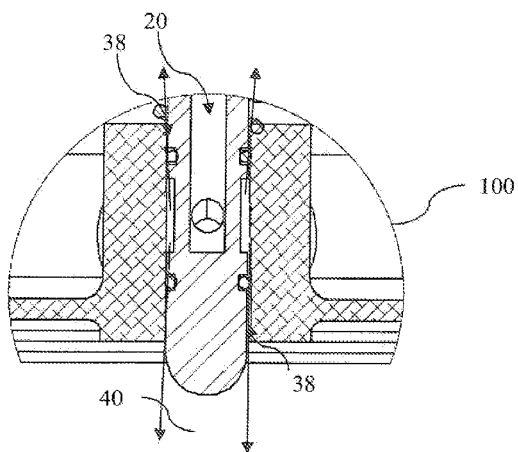
FIG. 13 is a scale 2:1 detailed view showing the increased clearance due to normal operating wear on a bore;

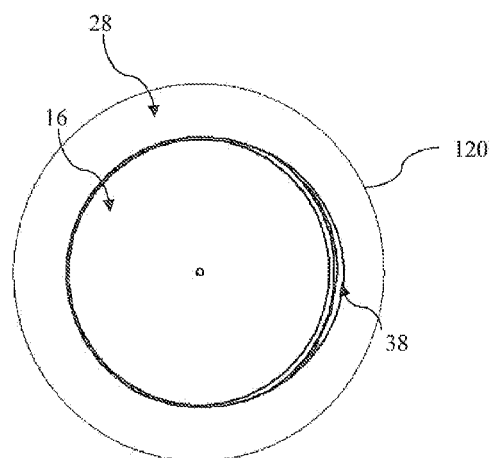
FIG. 14 is a scale 6:1 detailed view showing an ob-round shaped wear on a bore looking at the end view of a rod as it would appear from inside the transmission reservoir;

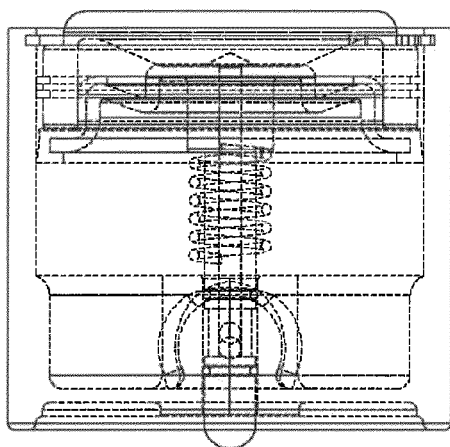
FIG. 15

FIGS. 15 & 16 are side and front views (hidden lines shown), showing the modified OEM parts with o-ring grooves and o-rings;

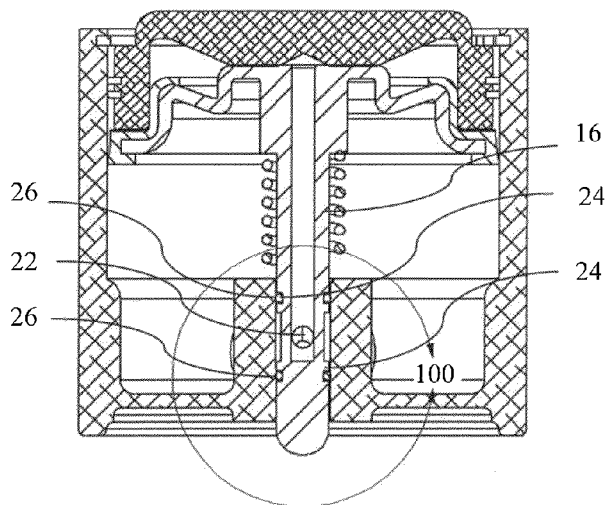
FIG. 17

FIGS. 17 & 18 are cross sections showing modified parts with o-ring grooves and o-rings sealing against the bore;

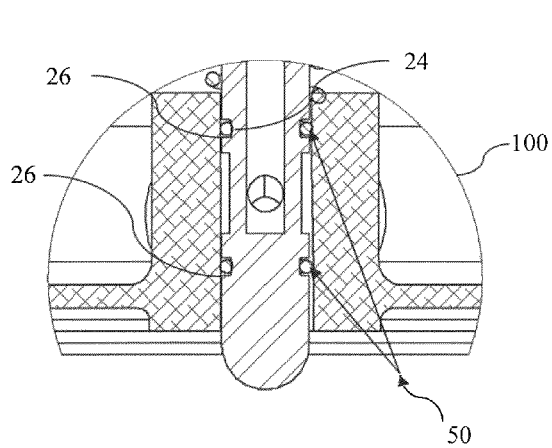
FIG. 19 is a scale 2:1 cross section showing o-ring grooves and o-rings, sealing a bore and directing fluid through a rod bore;

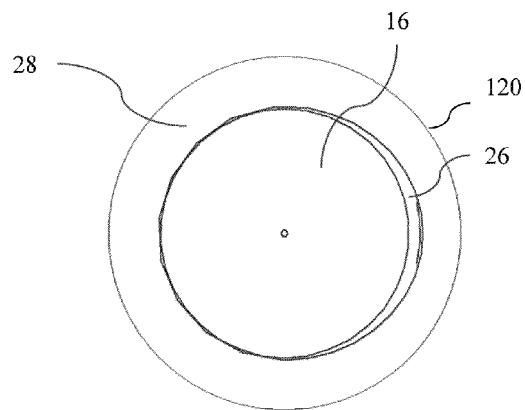
FIG. 20 is a scale 6:1 detailed view of the end of a rod and a bore showing the o-ring sealing an ob-round wear point;

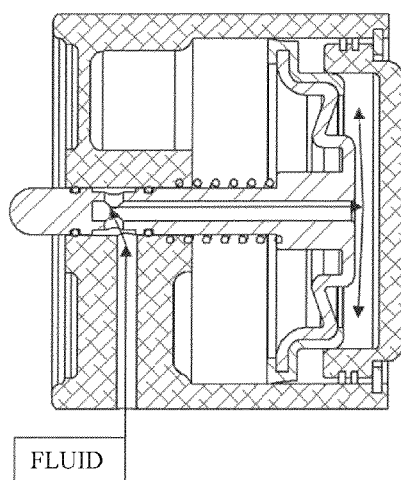
FIG. 21 is a section view showing a servo extended and the relative positions of o-rings with respect to the ends of a bore, as well as redirection of fluid flow;

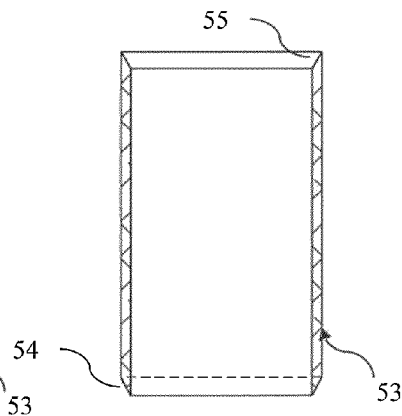
FIG. 22C is a two-dimensional cross section of an assembly sleeve;

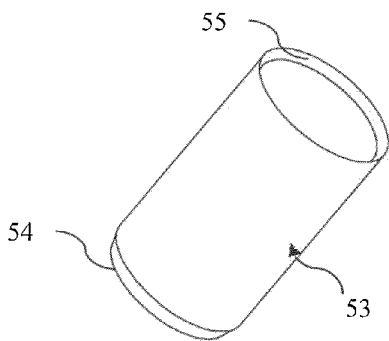
FIG. 22D is an isometric view of an assembly sleeve;

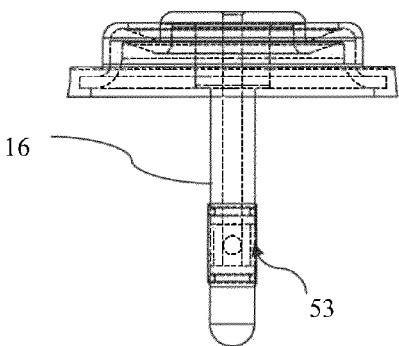
FIG. 23 is a two-dimensional view of an intermediate servo with an assembly sleeve shown in the installed position prior to installation of the servo into a bore.

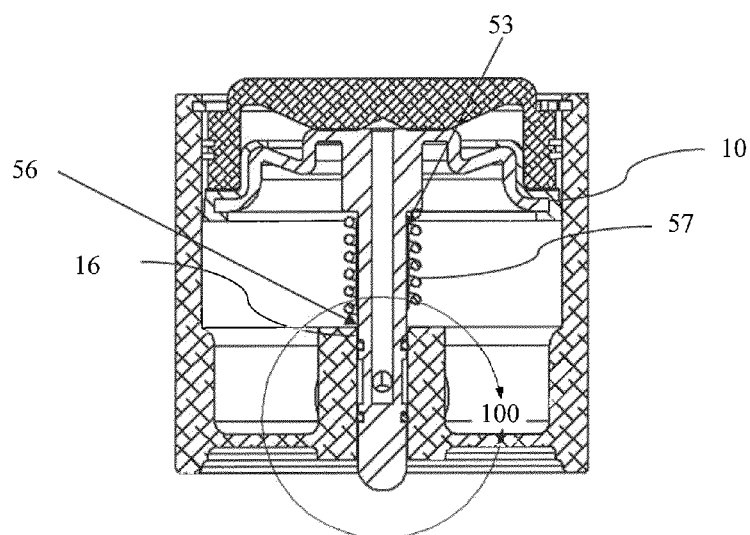
FIG. 24 is a cross section showing an assembly sleeve in the operating position after installation of the servo into a bore;
